USACERL Technical Report 98  
SFIM-AEC-ET-CR-98009  
July 1998

# Evaluation of Two Washrack Recycle Treatment Systems

This study evaluated two commercial off-the-shelf washrack wastewater recycle treatment systems (a Landa and an RGF) to determine their applicability at Army facilities. The evaluation assessed the resource requirements for installation, operation, maintenance and repair, and also assessed the effectiveness of the treatment. The two systems were found to use somewhat similar treatment processes. After a 3-month evaluation for each system, the results of the evaluations were also similar. Both systems

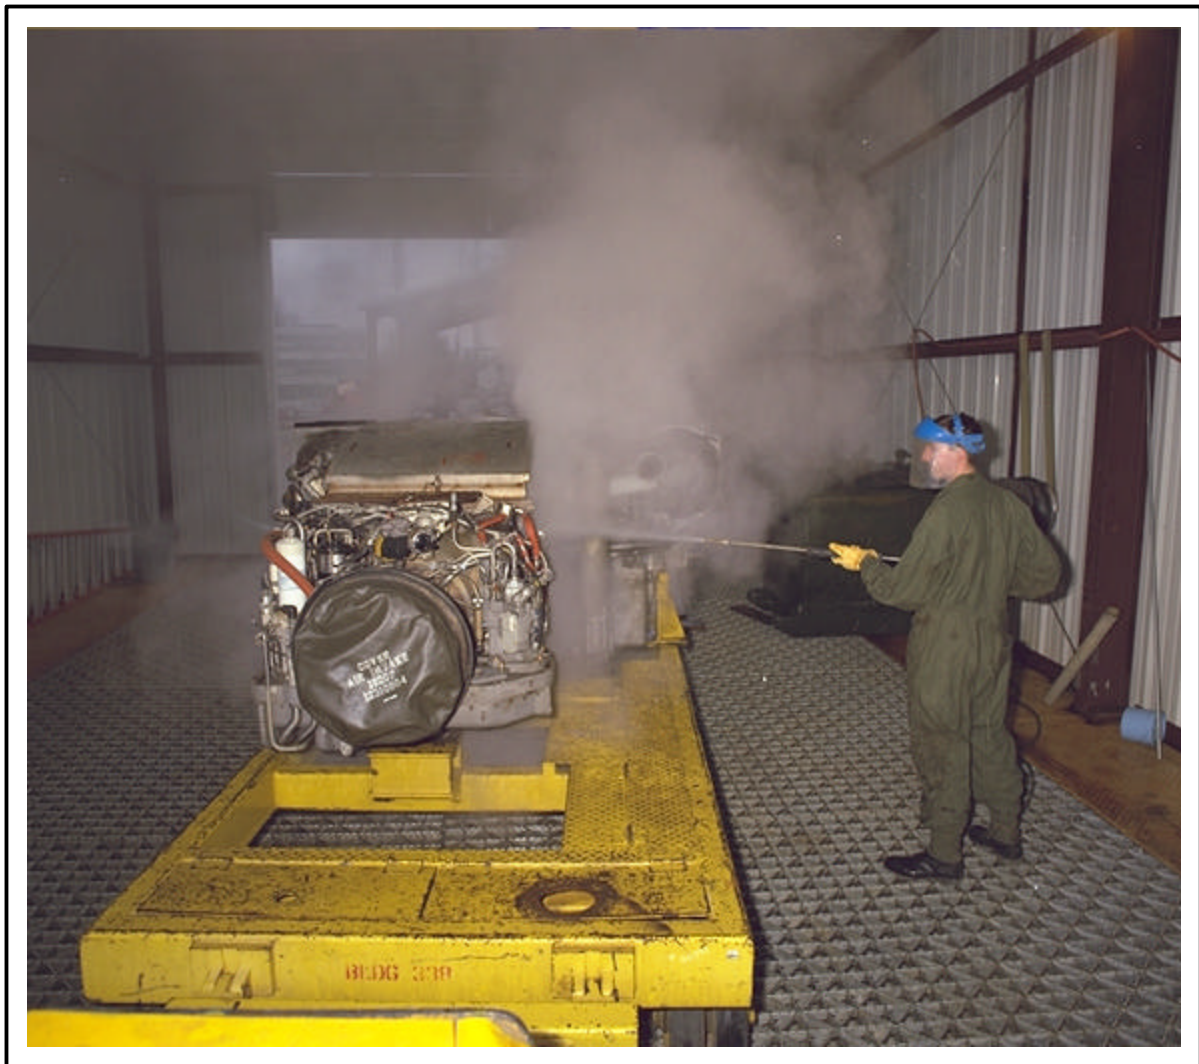
Figure 5. Washing equipment at Building 338 washrack.

The washrack also provided pretreatment in the form of solids removal prior to pumping washwater to the recycle systems. The wash area was constructed above a sloped drain pan that served as a solids settling and collection basin. Total volume of water and solids contained by this basin is about 45 cu ft. Figure 5 shows an M1 powerpack being washed at the Building 338 washrack.
